PROPERTY INSPECTION REPORT

Report #: RF20050929-01

Concerning: Anywhere USA, TX -
(Address of Inspected Property)

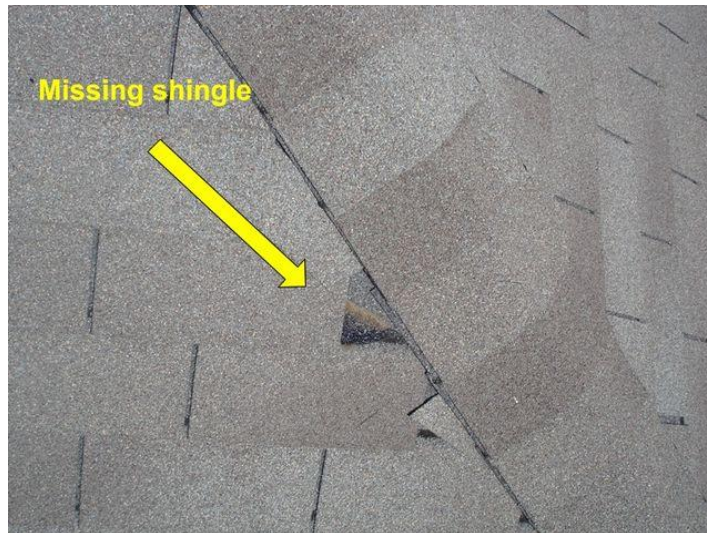
Ⓟ small piece of shingle missing by ridge back right part of house (laundry area)

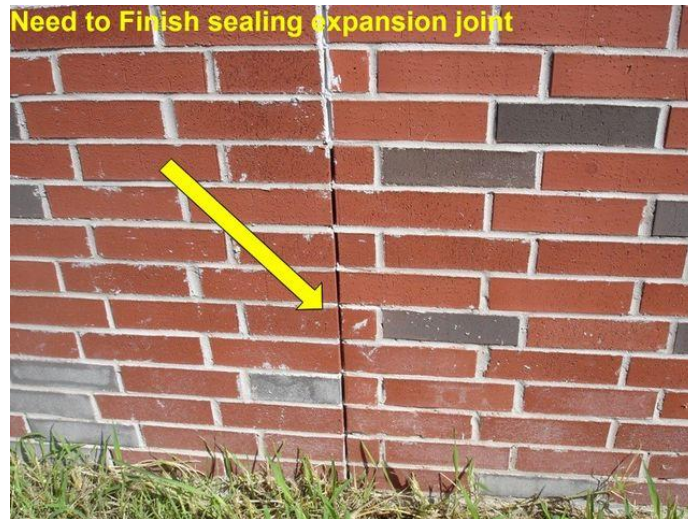
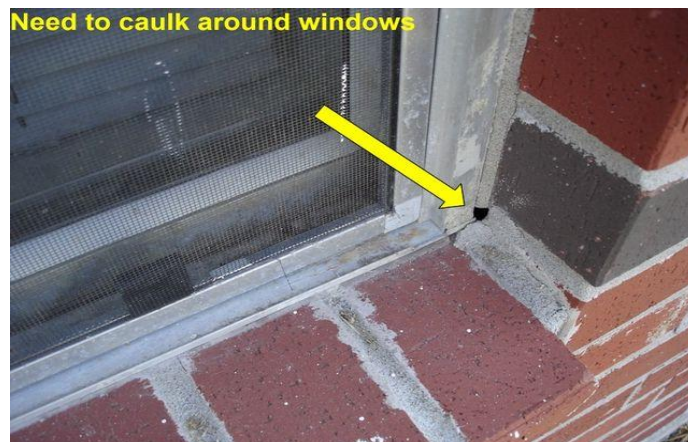
- Ⓟ Expansion joint should be filled with caulk or similar sealant
- Ⓟ Found various perforations along windows/brick, recommend caulking around windows

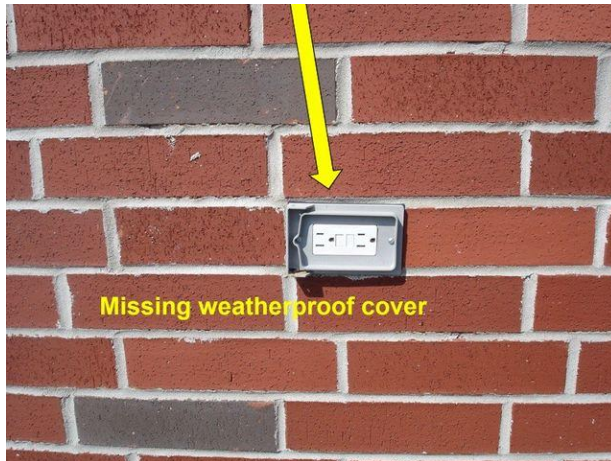
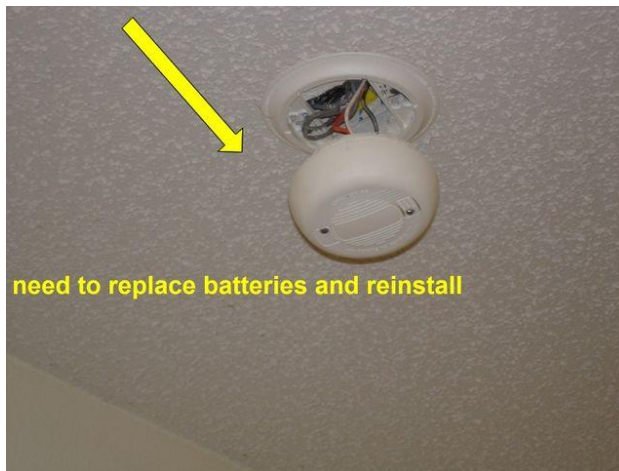
- ⌋ GFCI does not reset in bathroom, suggest licensed electrician to replace
- ⌋ GFCI plugs do not have covers in back of house, these must be covered to avoid possible breakers from tripping
- ⌋ Smoke detectors need batteries replaced

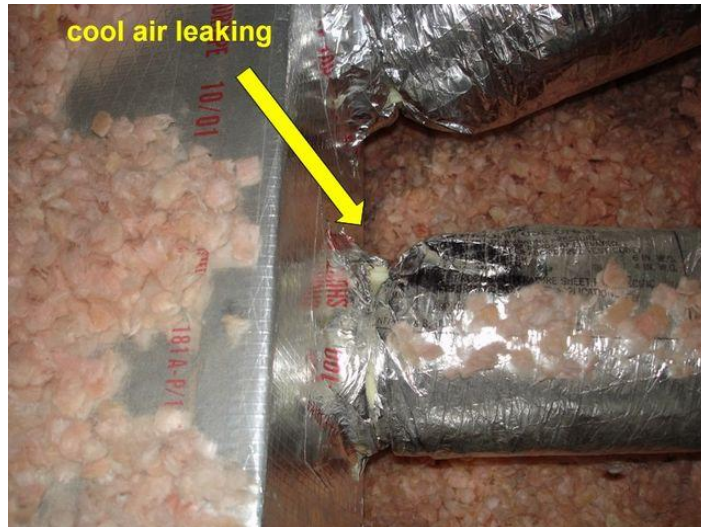
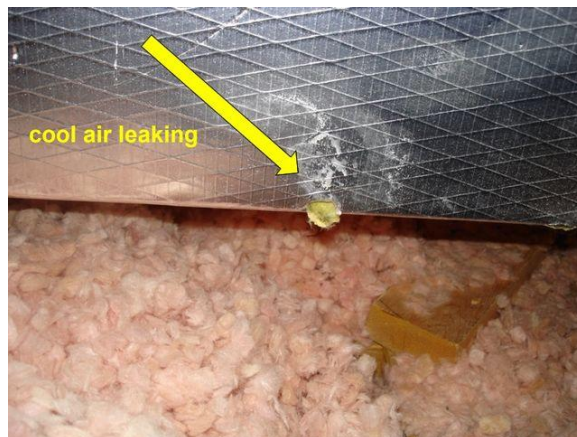
- ␣ Found various leaks in ductwork, recommend HVAC technician to reseal
- ␣ Found no air filter, recommend HVAC to check duck work for dirt residue

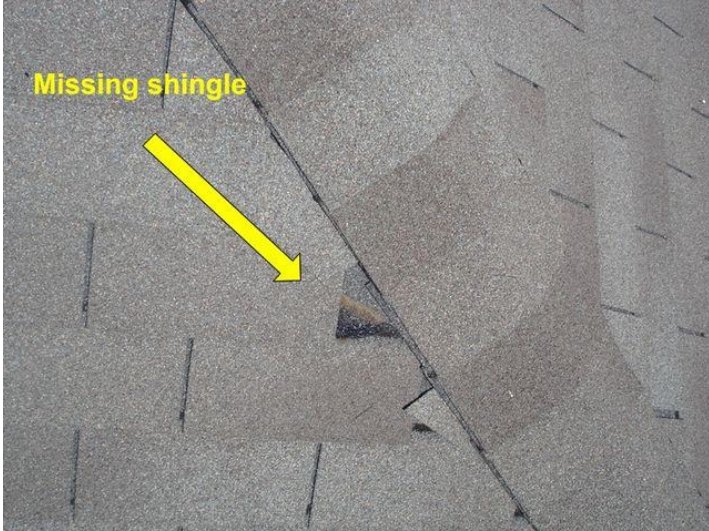
Roof Covering

- ⌋ small piece of shingle missing by ridge back right part of house (laundry area)

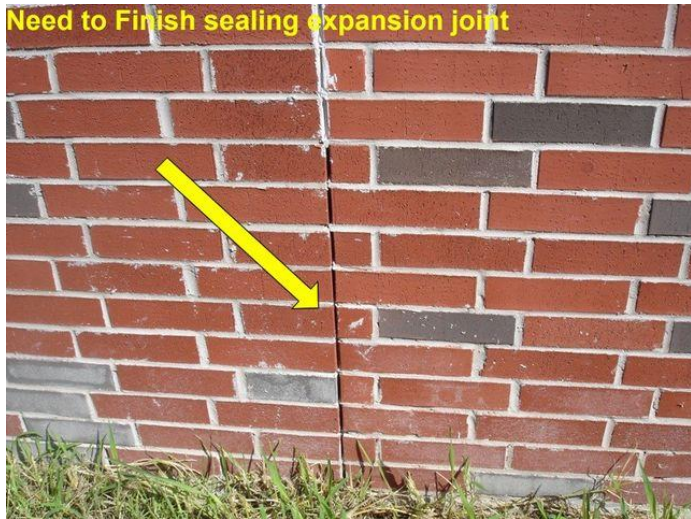
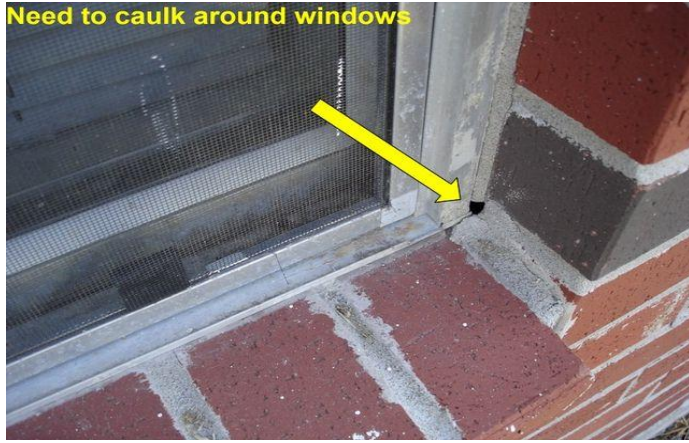
Walls (Interior and Exterior)

- ⌋ Expansion joint should be filled with caulk or similar sealant
- ⌋ Found various perforations along windows/brick, recommend caulking around windows

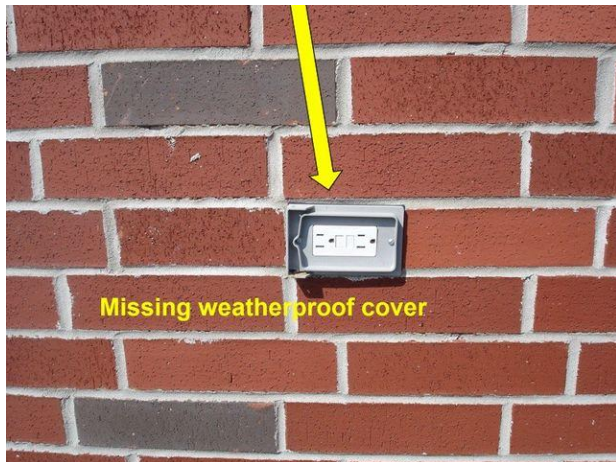
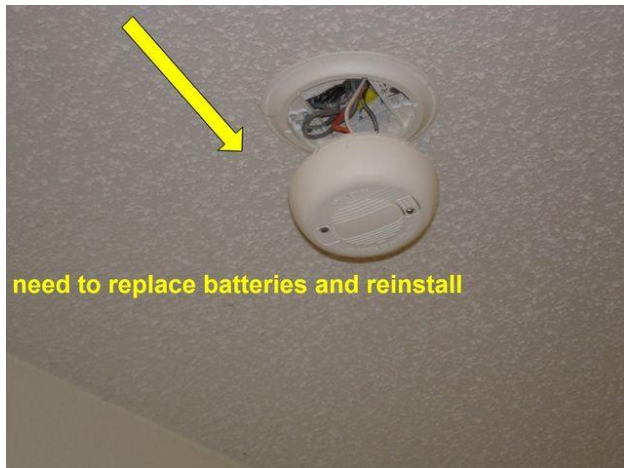
Electrical Systems
Electrical Branch Circuits

- GFCI does not reset in bathroom, suggest licensed electrician to replace
- GFCI plugs do not have covers in back of house, these must be covered to avoid possible breakers from tripping
- Smoke detectors need batteries replaced

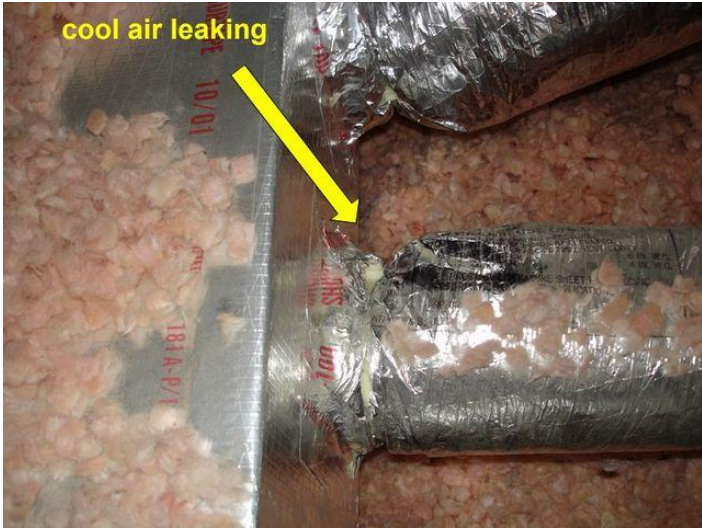
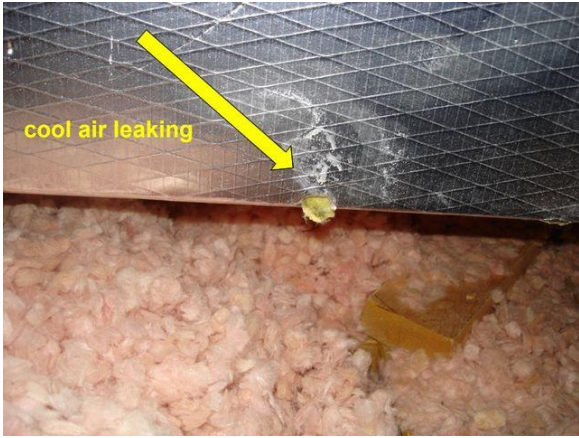
Heating, Ventilation, A/C Systems
Ducts and Vents

- Found various leaks in ductwork, recommend HVAC technician to reseal
- Found no air filter, recommend HVAC to check duck work for dirt residue
